<b>EASA</b>	<b>EMERGENCY AIRWORTHINESS DIRECTIVE</b>

<p><b>AD No.: 2014-0118-E</b></p> <p><b>Date: 13 May 2014</b></p> <p>Note: This Emergency Airworthiness Directive (AD) is issued by EASA, acting in accordance with Regulation (EC) No 216/2008 on behalf of the European Community, its Member States and of the European third countries that participate in the activities of EASA under Article 66 of that Regulation.</p>	
<p>This AD is issued in accordance with EU 748/2012, Part 21.A.3B. In accordance with EC 2042/2003 Annex I, Part M.A.301, the continuing airworthiness of an aircraft shall be ensured by accomplishing any applicable ADs. Consequently, no person may operate an aircraft to which an AD applies, except in accordance with the requirements of that AD, unless otherwise specified by the Agency [EC 2042/2003 Annex I, Part M.A.303] or agreed with the Authority of the State of Registry [EC 216/2008, Article 14(4) exemption].</p>

<p><b>Design Approval Holder Names:</b> BELL HELICOPTER TEXTRON Inc.</p>		<p><b>Type/Model designation(s):</b> 212, 412, and 412EP helicopters</p>
<p>TCDS Numbers:     FAA USA H4SW</p>		
<p>Foreign AD:         None</p>		
<p>Supersedure:       None</p>

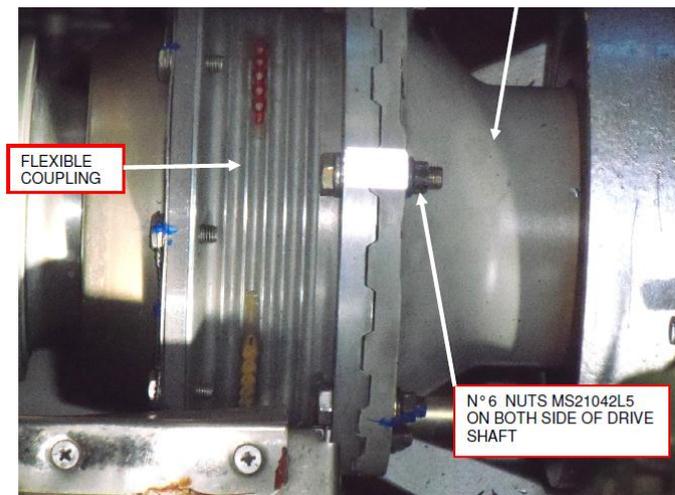
Fig. 1

1. Prepare helicopter for safe ground maintenance; disconnect battery and all the electric power source and/or the external power supply.
2. In accordance with the applicable Maintenance Manual Chapter 63, gain access to the engine-to-transmission drive shaft.
3. Using a source light and a mirror, inspect the nuts P/N MS21042L5 connecting the flexible coupling with the adapter installed on the engine-to-transmission drive shaft (refer to Fig. 1) or inspect the nuts P/N MS21042L4 connecting the flexible coupling with the adapter and nuts P/N MS21042L4 connecting the drive shaft with the flexible coupling (refer to Fig. 2). The configuration depends on the helicopter model and s/n.

1. In accordance with the applicable Maintenance Manual Chapter 63, replace the nuts P/N MS21042L5 with nuts P/N MS21043-5 or the nuts P/N MS21042L4 with nuts MS21043-4, as applicable depending on helicopter configuration (it is recommended to replace the nuts one at a time). Restore witness mark as required.
2. In accordance with the applicable Maintenance Manual Chapter 63, reinstall the access panel and close the access doors previously removed/opened and return the helicopter to a “ready to flight” condition.
